# Smart Cooler

Week 29 Feb 17 – Feb 23

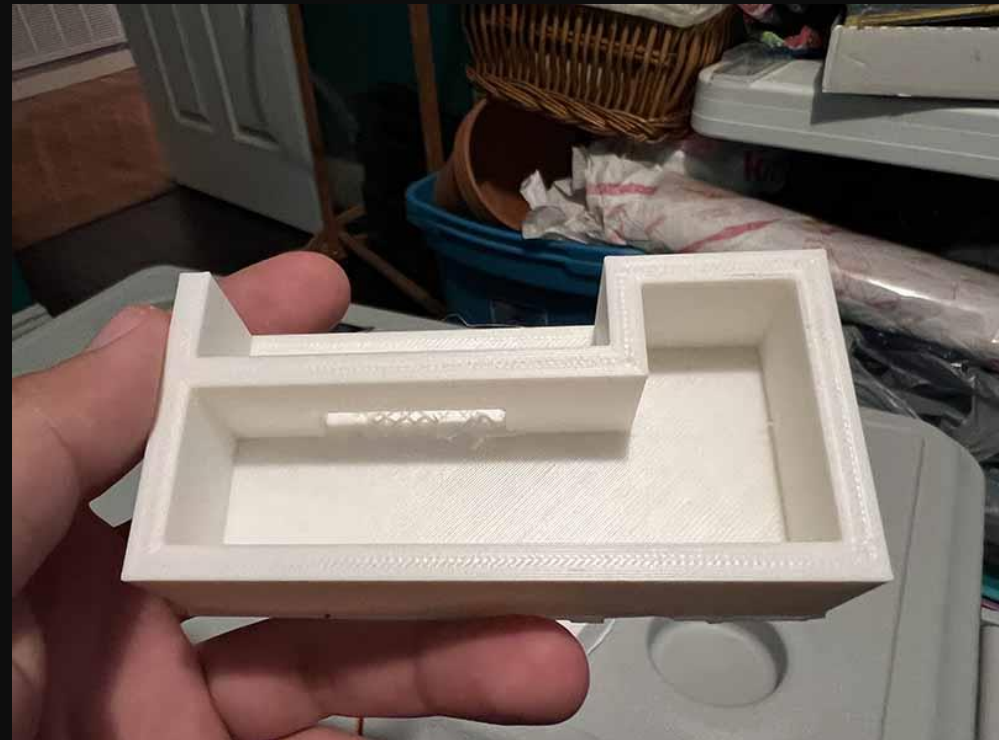
# Door Position Sensor Bracket

- Will be placed on body of cooler.
- Wires will run to door position sensor.
- Created hollow to allow for wires and screwing to cooler.
- Dimensions are 4" long by 2" high by 1" wide.
- Took 5.5 hours to print

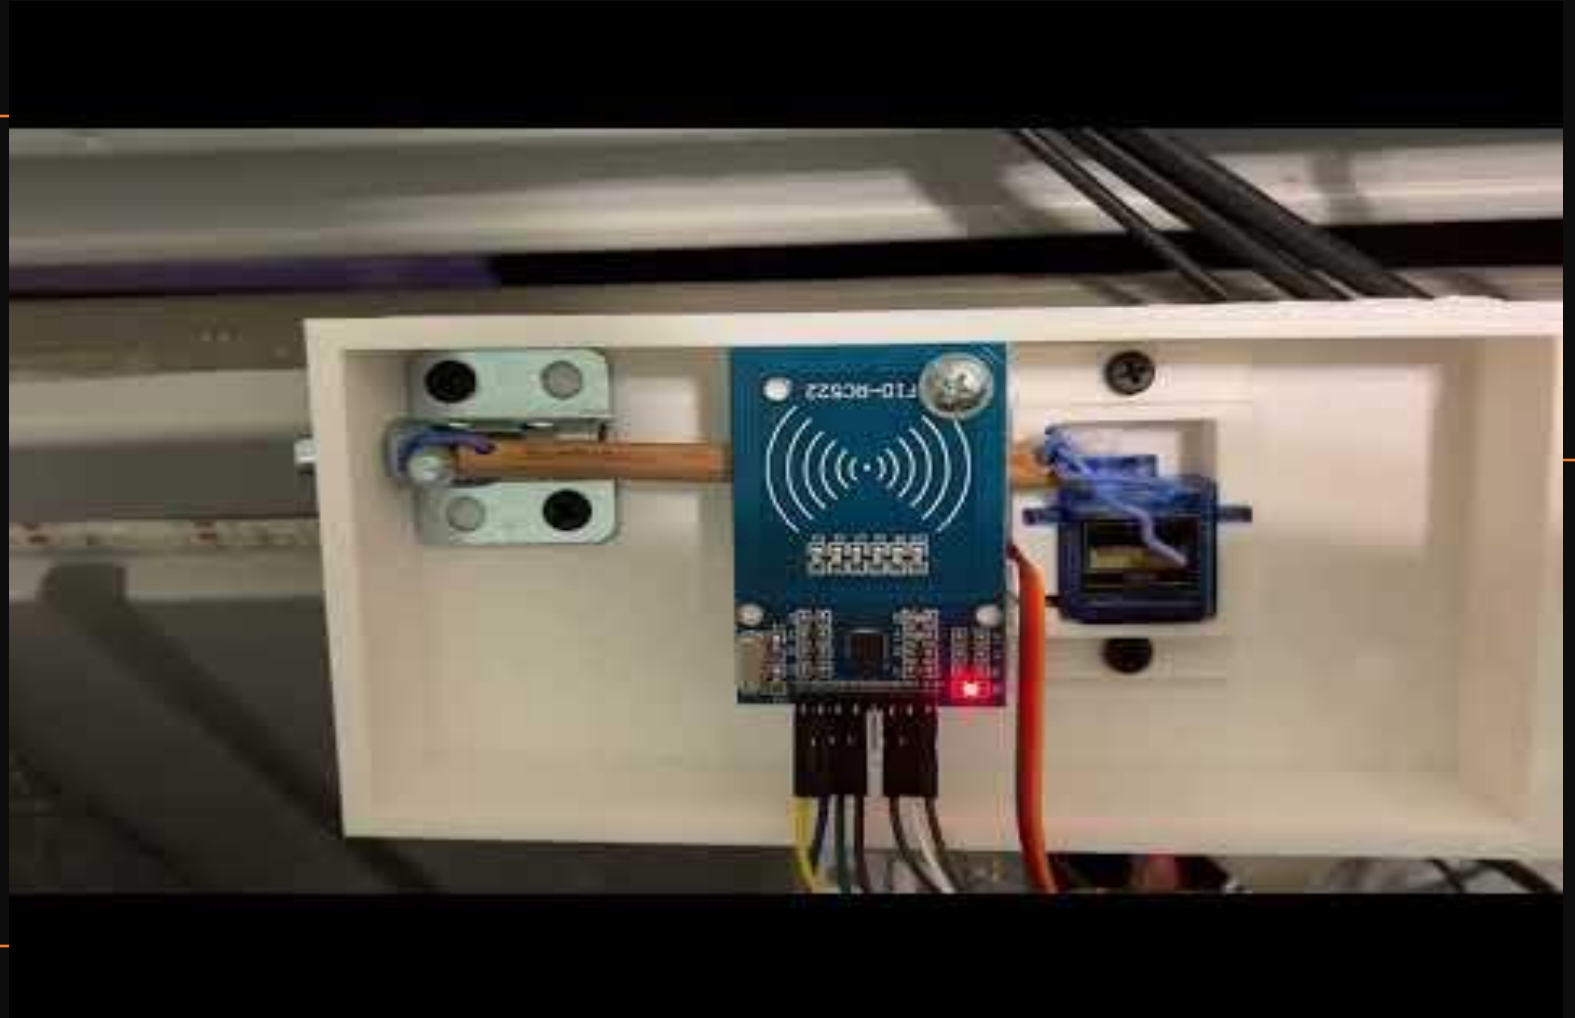
# Sliding Lock Test

- Video shows the RFID being tagged with an RFID keychain, which then activates the servo and moves the sliding lock into the lock and unlock positions.

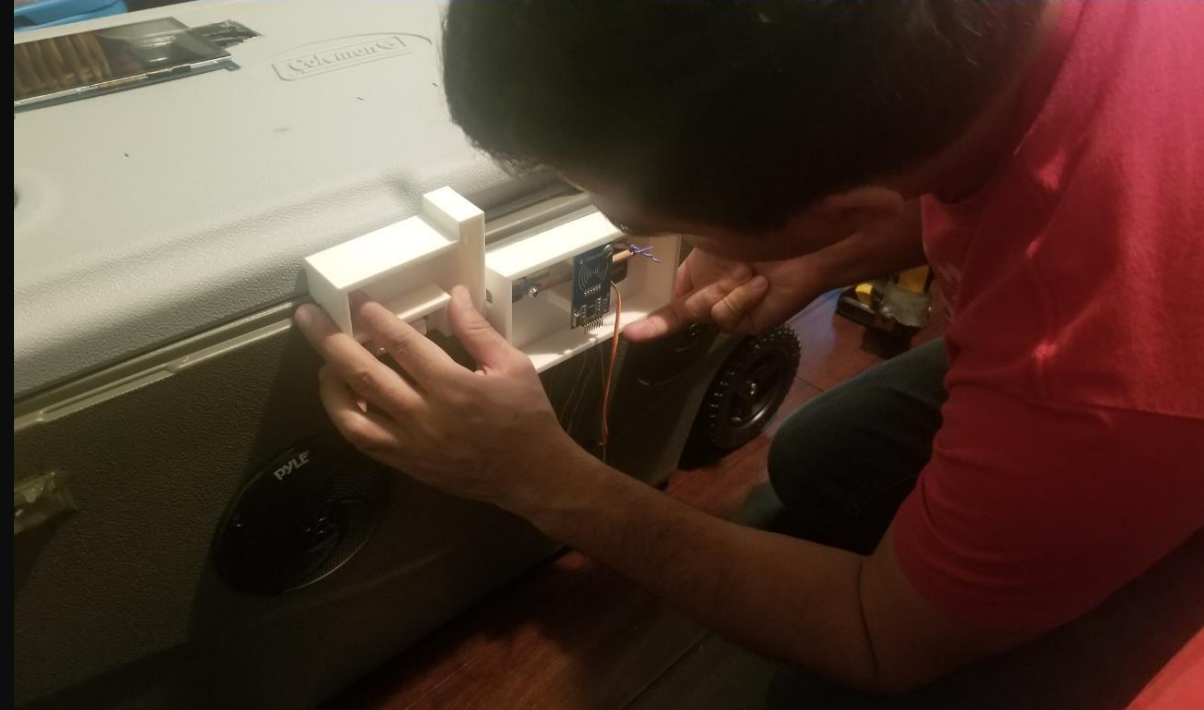
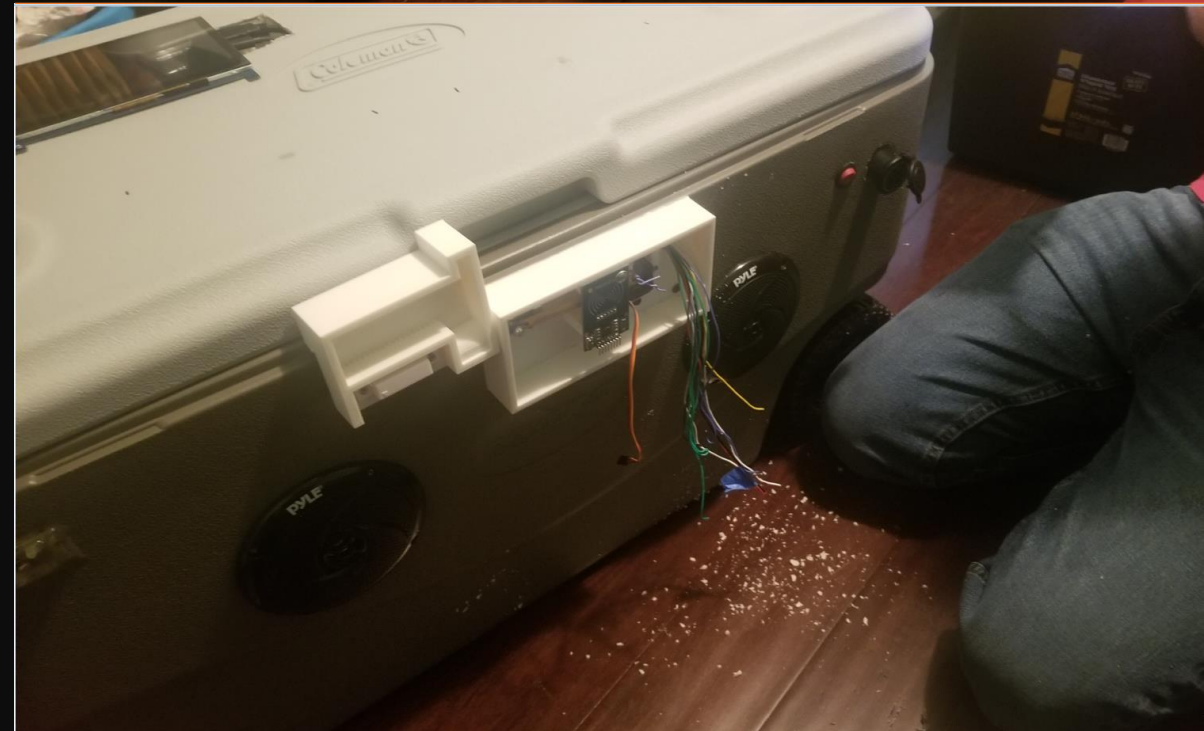
# Part Assembly

- 3D Printed parts were dry-fitted and placed
  - Wires were shortened to proper length
-

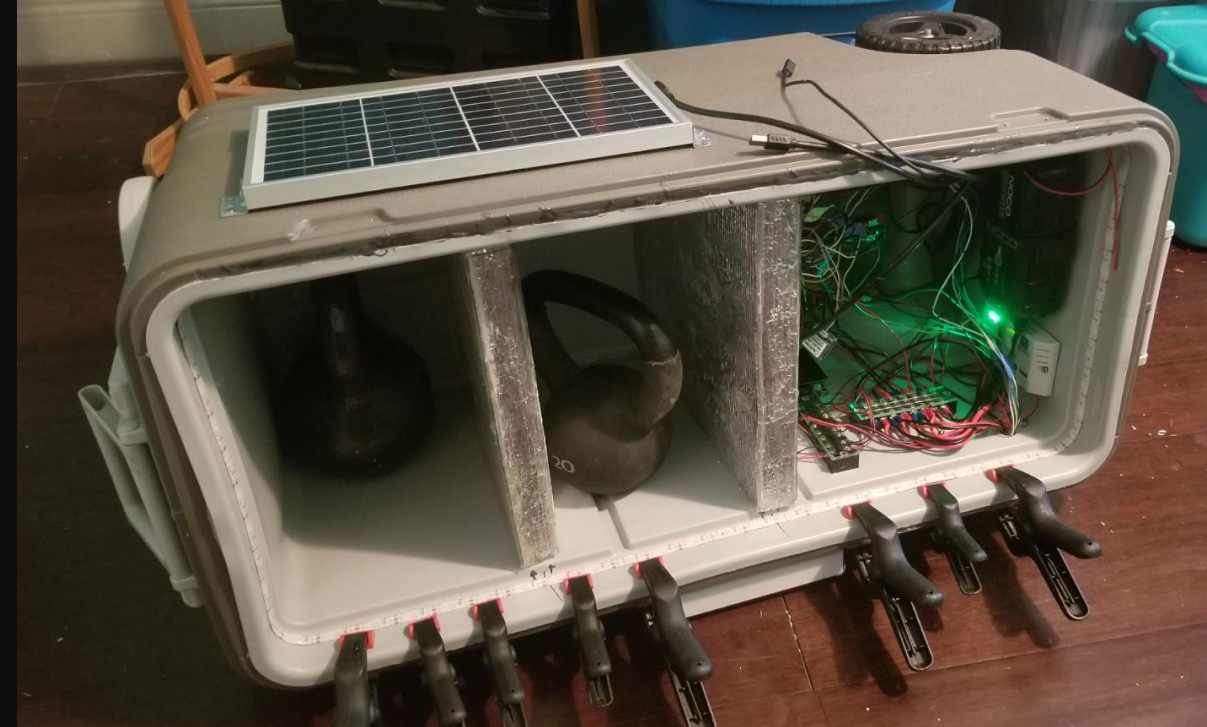
# Inner Wall Closure

- The inner walls were filled in with an insulating foam
  - A two-part waterproof epoxy was used to glue and seal the sides of the shells back together
-

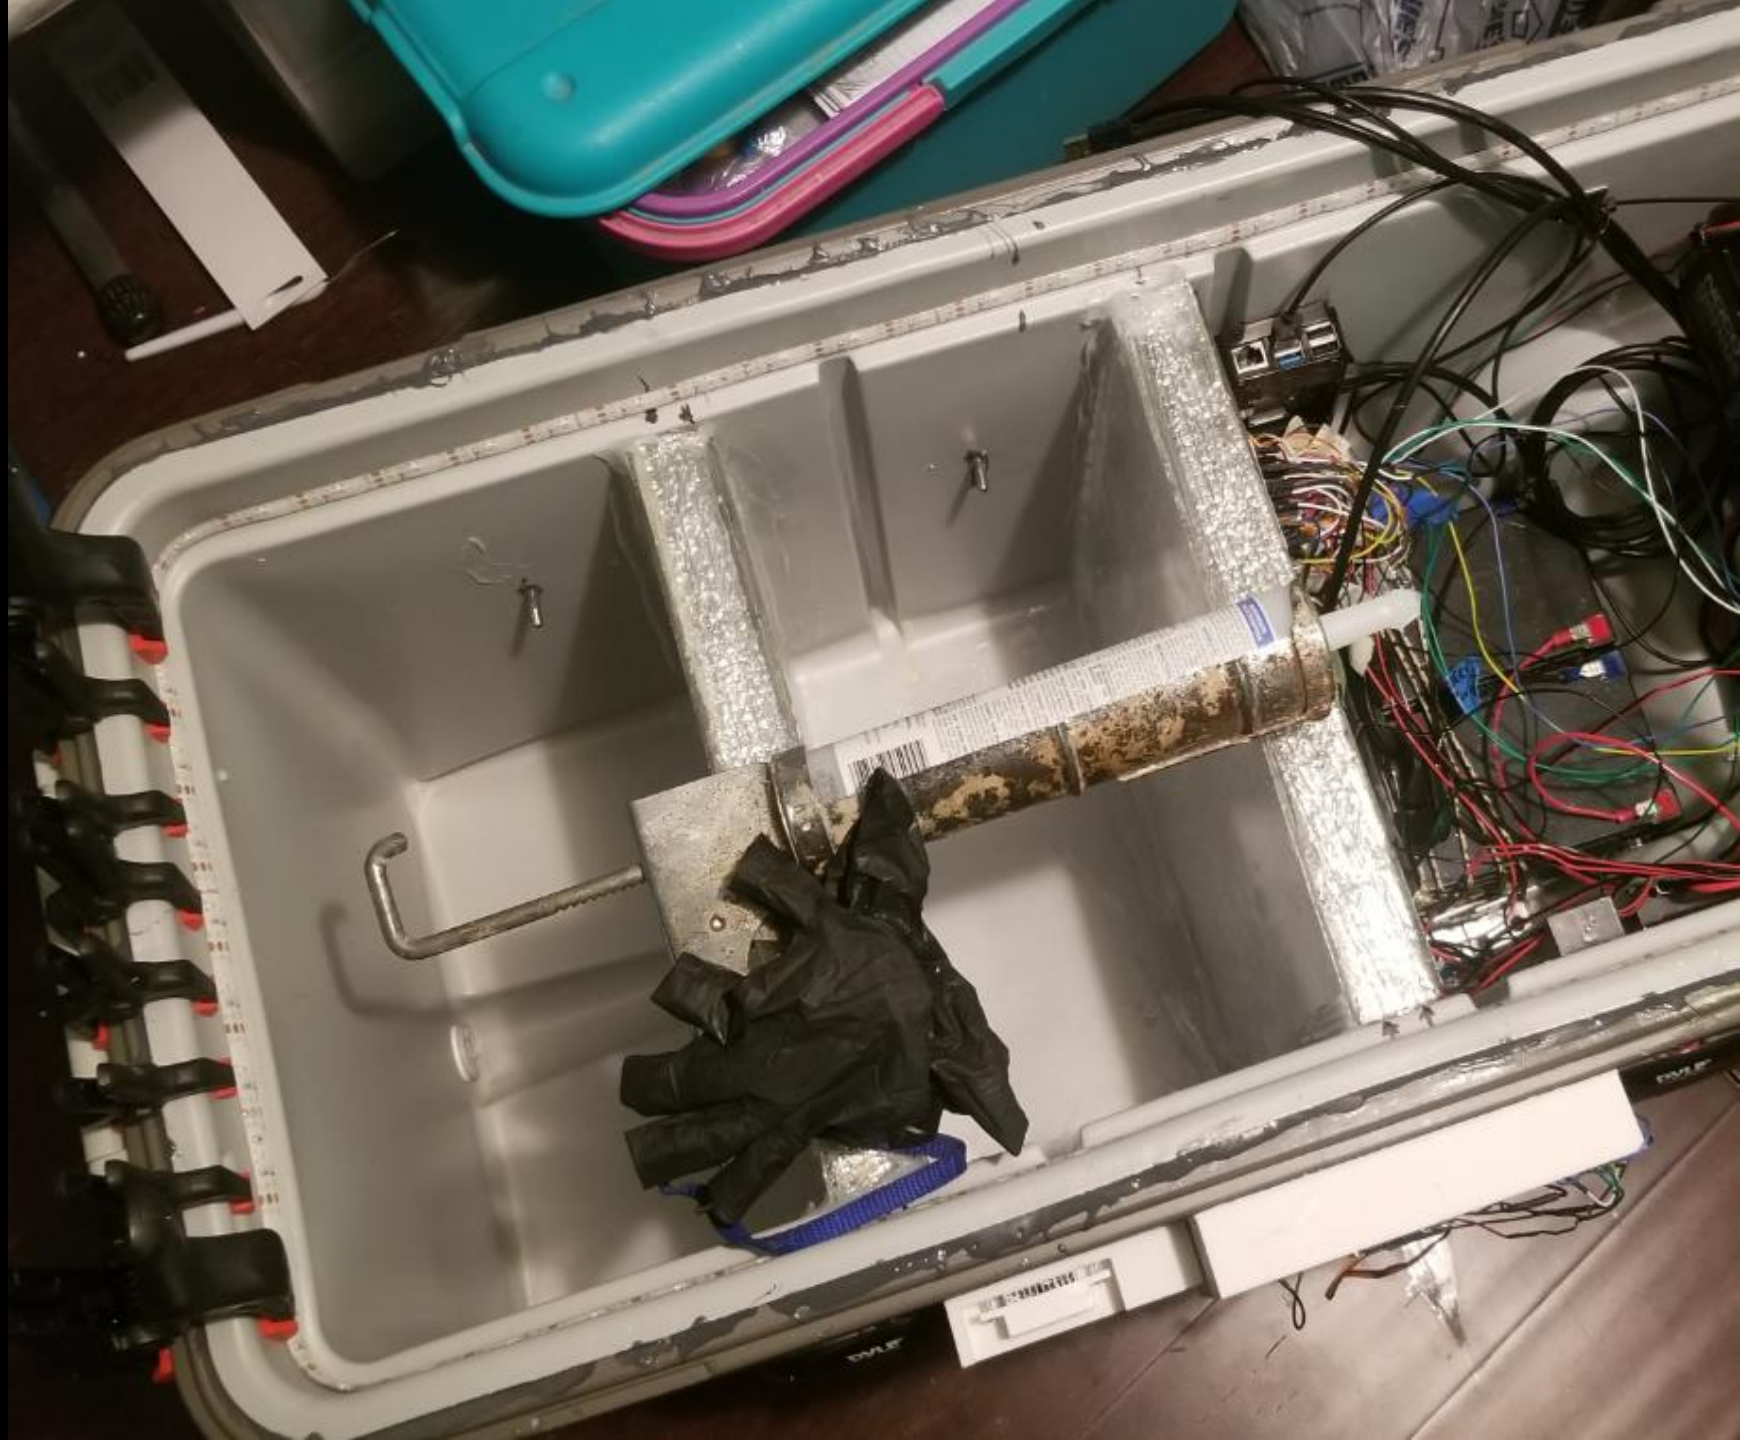
## Securing Dividers

- Both Dividers were placed and secured
- Waterproof silicon was applied to all of the joints to ensure there are no leaks

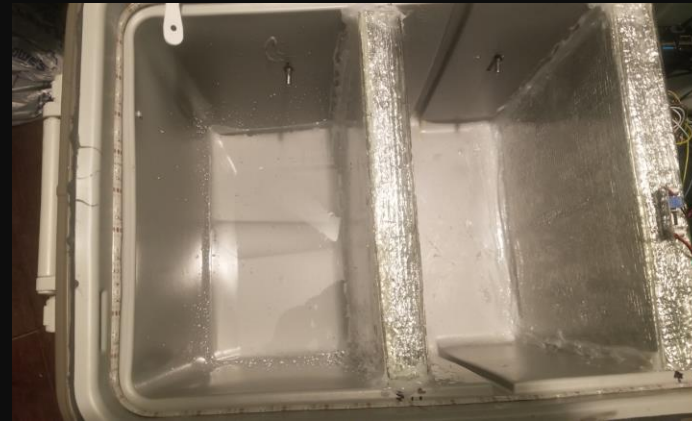
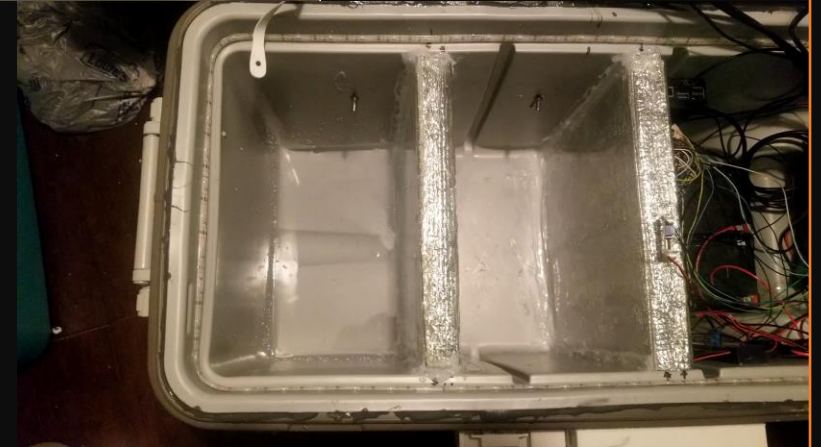
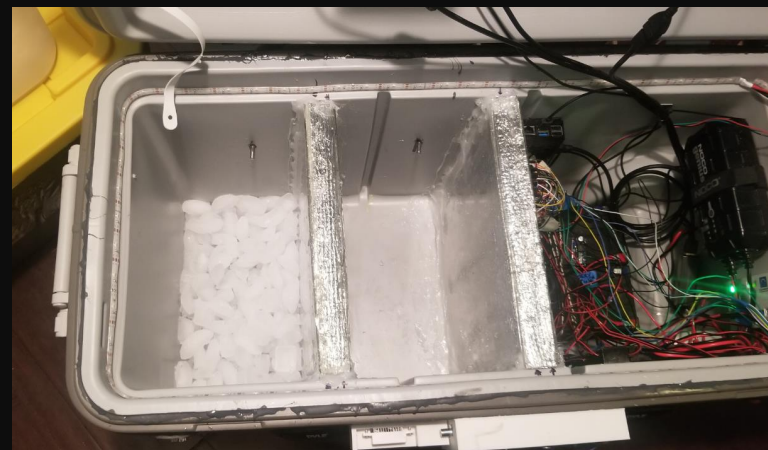
# Testing

- To water added to test for leaks
- No leaks found in either compartment
- Ice added to first compartment

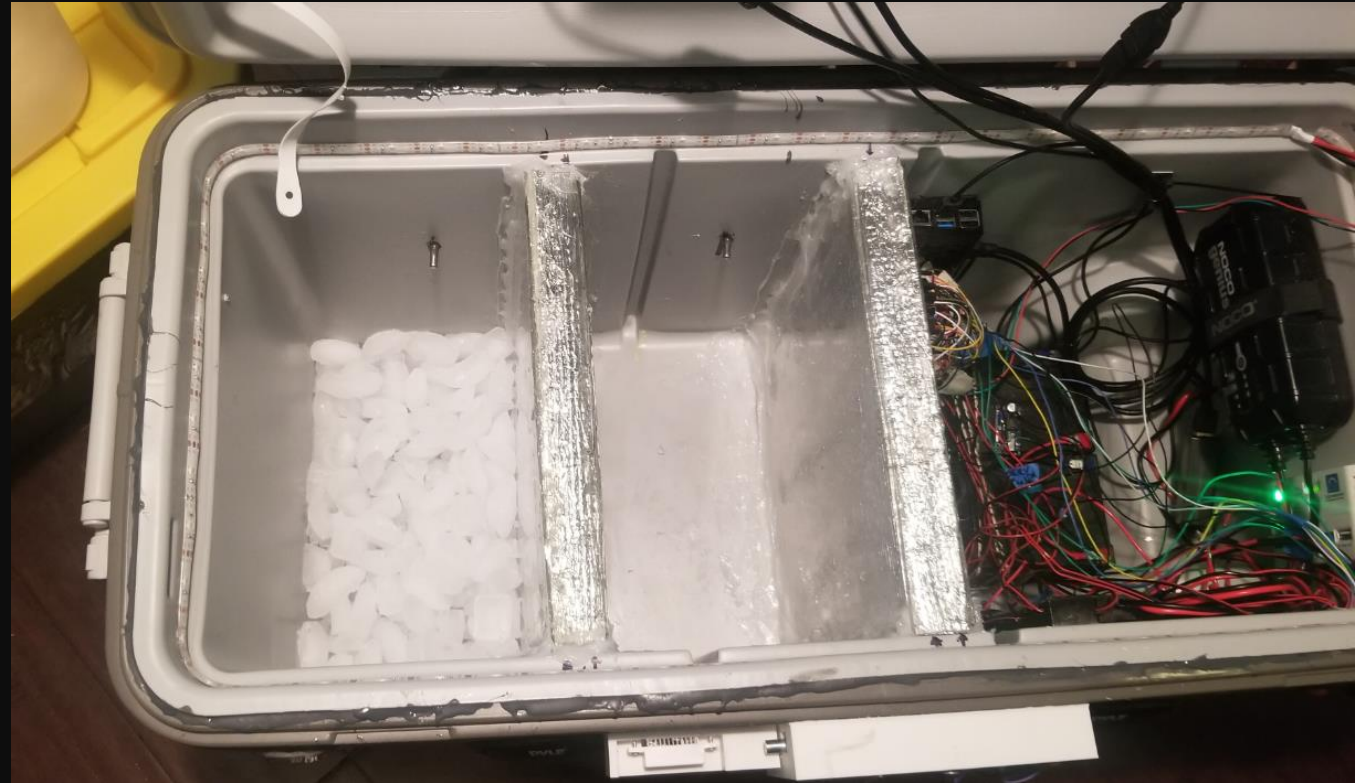
# Ice Retention Control

- Added roughly 5 lbs of Ice to furthest compartment
  - After 6 hours divider and silicon seal held
  - Significant amount of ice remained
  - Temperature in compartment noticeably cooler than neighboring compartment
-
