Smart Cooler

Week 30 Feb 24 – Mar 2

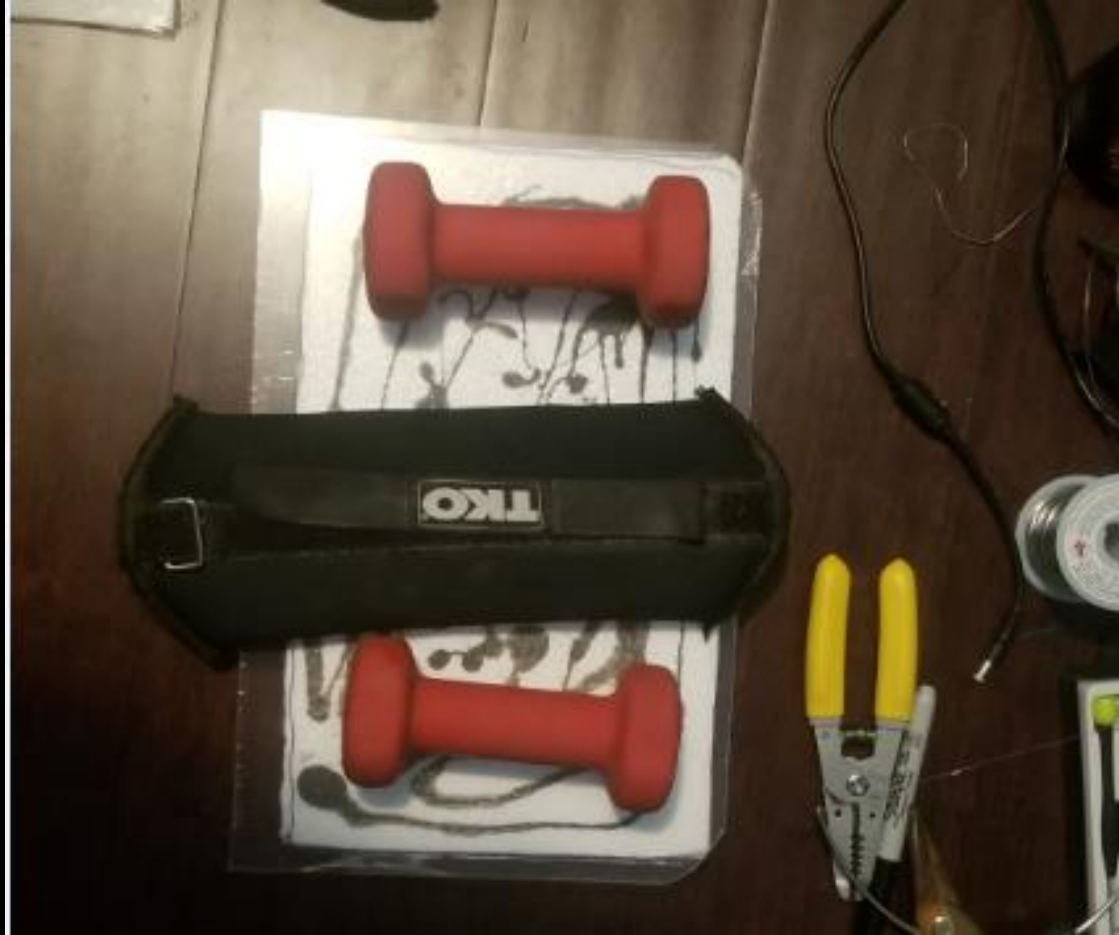
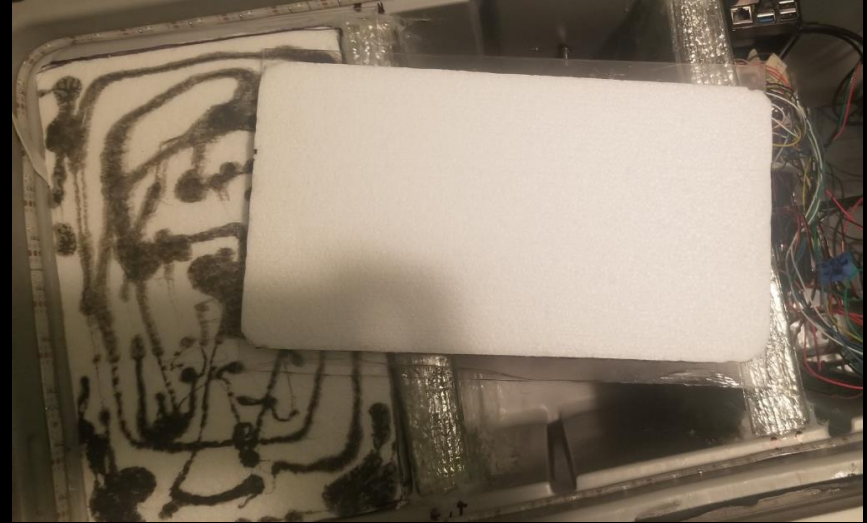
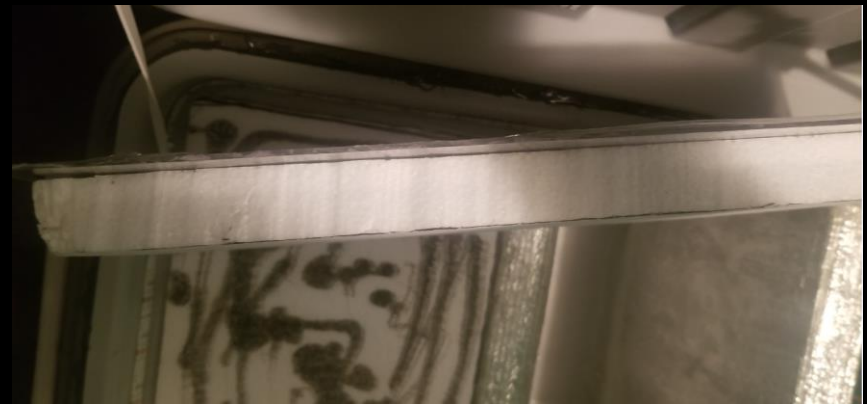
Compartment Lids

- Both lids were made of Plexiglass and Styrofoam
- Both fit snugly and securely
- Both successfully insulated each compartment

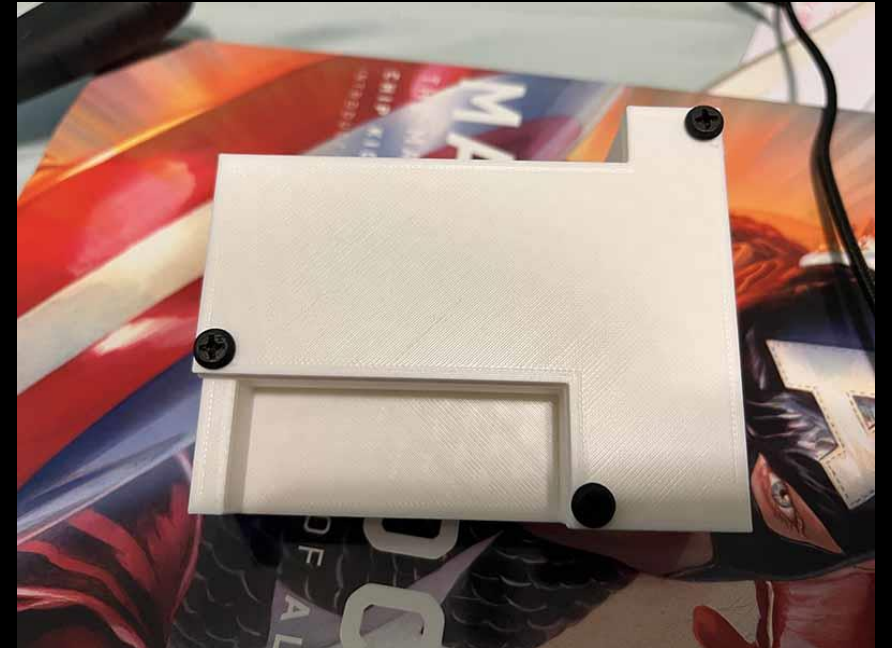
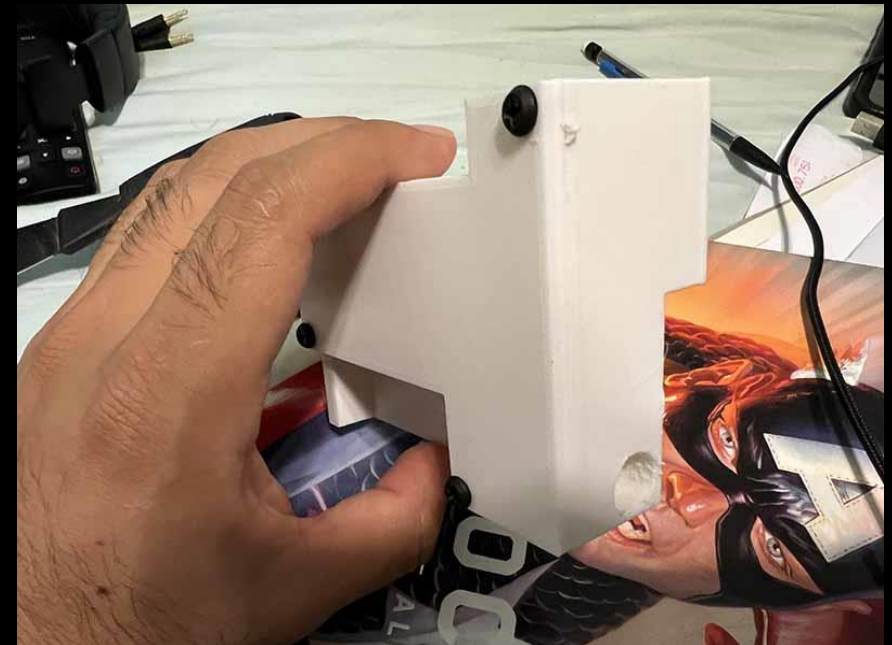
Locking Mechanism Covers

- The cover was screwed directly onto the lock lid bracket
- The side view of the bracket shows a tight seal.
- Also, the lock lid bracket sliding lock hole was readjusted and the part was reprinted as there were issues with the lock not sliding all the way.

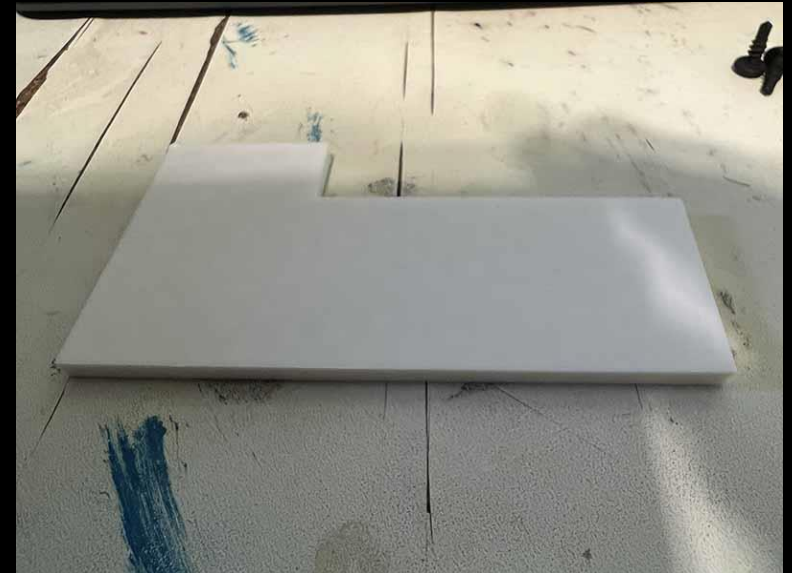
Locking Mechanism Covers

- This cover is for the door position sensor case on the cooler body.
- This is a clean print.
- The screw holes have not been drilled yet.

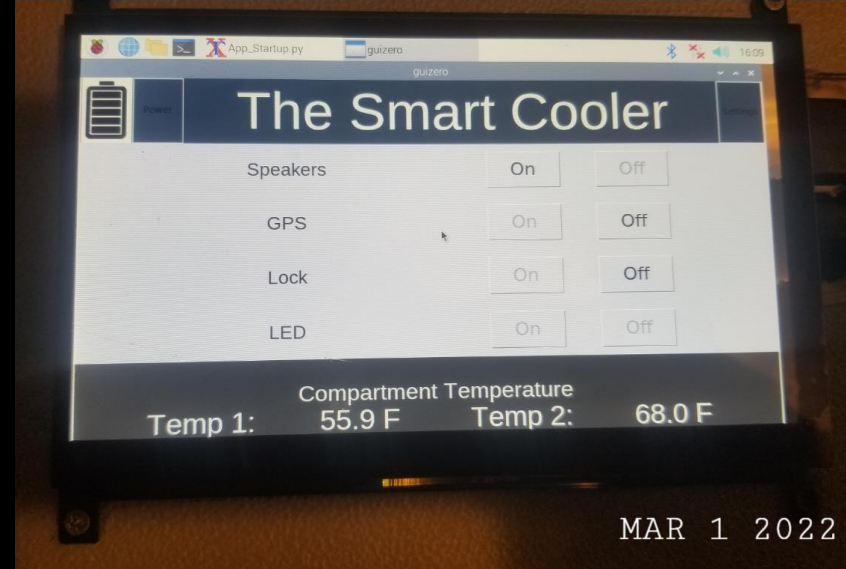
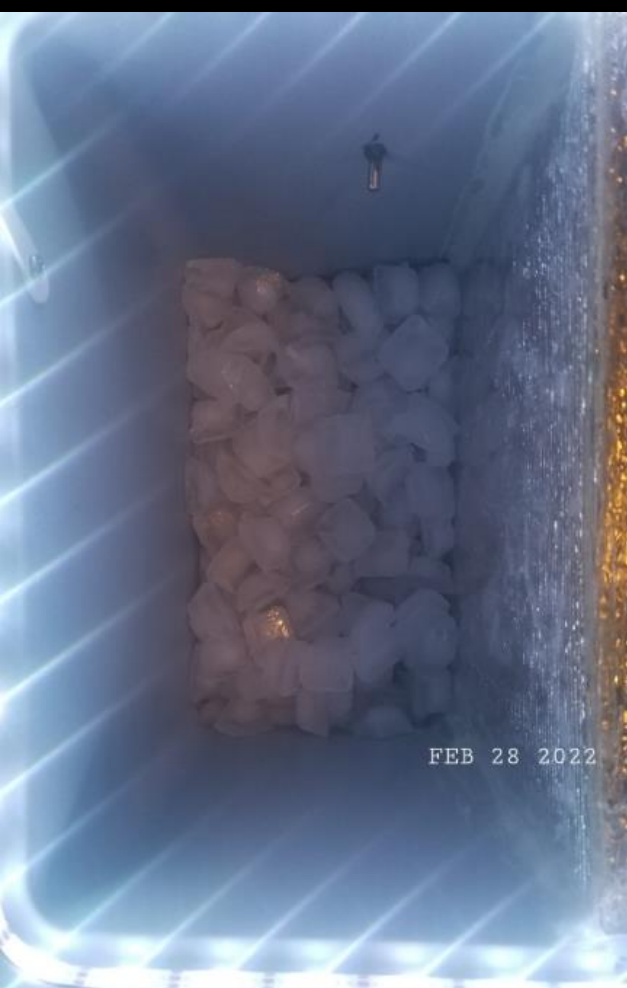
Testing

- Roughly Five pounds of ice was added to the first compartment
- The system was used to check the temperature
- Test confirmed the proper operation of the systems thermometers
- Temp was checked every 3 hours for 24 hours
